Manhole Inspection Summary

Manhole # S53I__005MH

Insp Date: **4/14/08 11:28 AM**

Location Address: **3134 south east avenue**

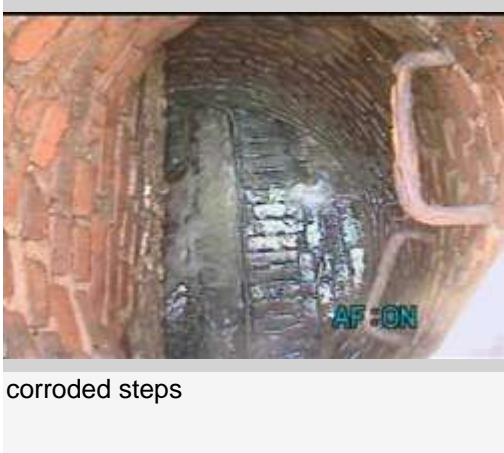
Defect 1

Steps Count: **5** Missing: **0** ☒ **Corroded**

corroded steps

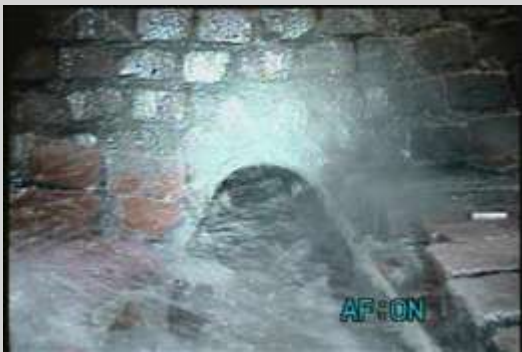
12 O'Clock Outflow

8 in. Circular Gravity Sewer
Pipe Out @ 12 O'Clock

Pipe Material: **Clay** ☐ Pipe Lined

Invert Depth: **9.20** (ft.) Flow Characteristics: **Fast**

Infiltration: **None** Pipe Seal Cond: **Unknown**

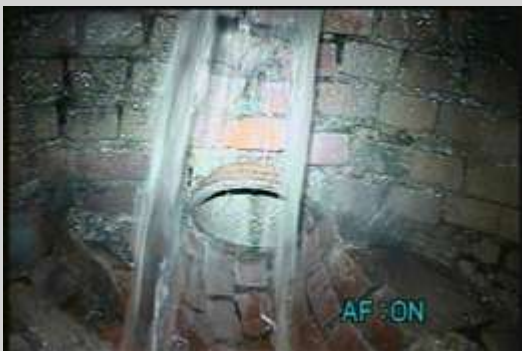
6 O'Clock Inflow

8 in. Circular Gravity Sewer
Drop In @ 9 O'Clock

Pipe Material: **Clay** ☐ Pipe Lined

Invert Depth: **9.00** (ft.) Flow Characteristics: **Fast**

Infiltration: **None** Pipe Seal Cond: **Unknown**

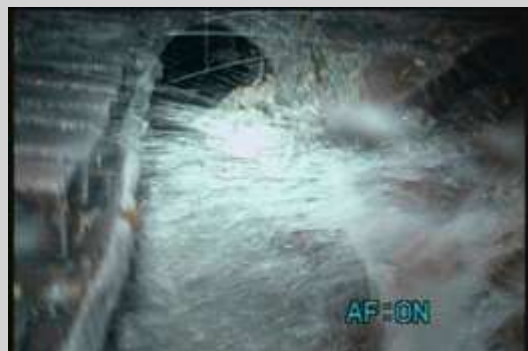
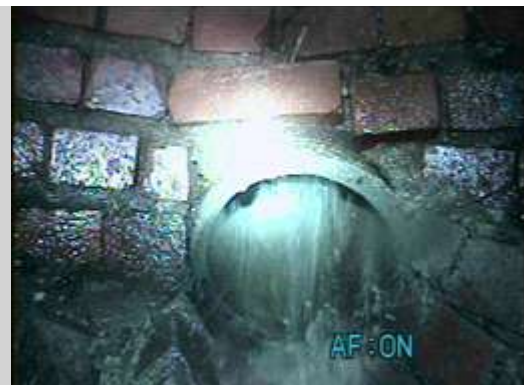
9 O'Clock Inflow

8 in. Circular Gravity Sewer

Pipe Material: **Clay** ☐ Pipe Lined

Invert Depth: **2.10** (ft.) Flow Characteristics: **Fast**

Drop: **Outside** **Direct**

Drop Condition: **Open**
